Welcome to RGS insite issue 8

CASE STUDY

A Tale of Three Slopes

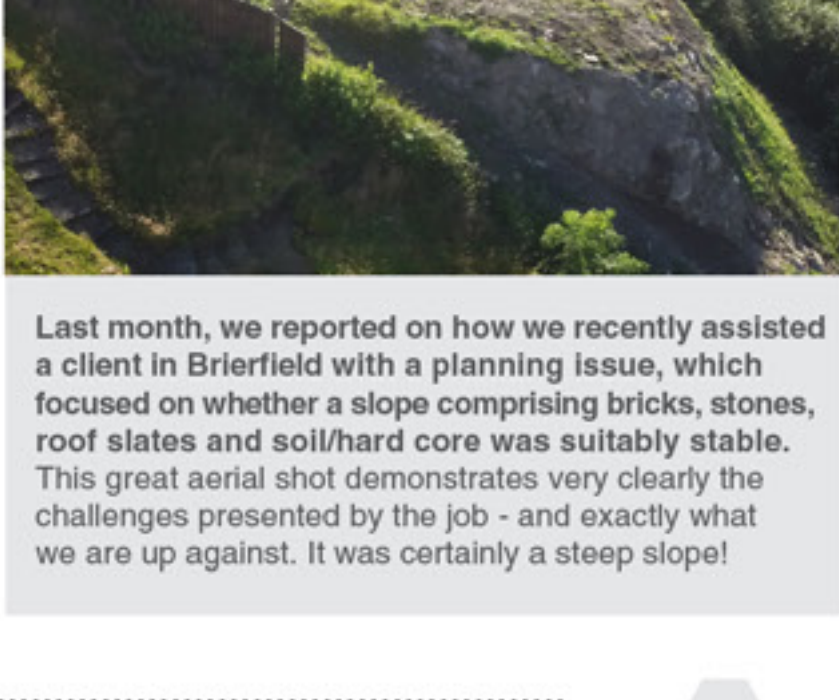
Slippery slope

Last month, we reported on how we recently assisted a client in Brierfield with a planning issue, which focused on whether a slope comprising bricks, stones, roof slates and soil/hard core was suitably stable. This great aerial shot demonstrates very clearly the challenges presented by the job - and exactly what we are up against. It was certainly a steep slope!

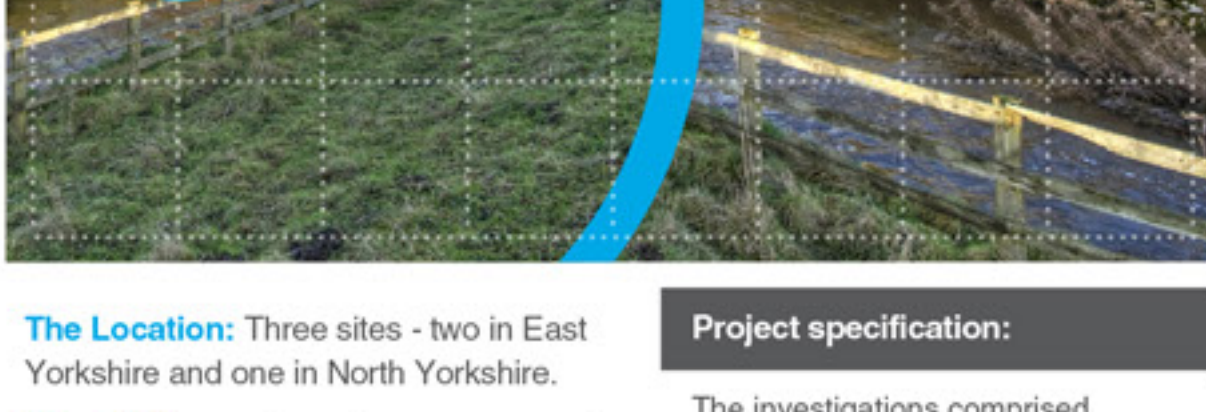
The Location: Three sites - two in East Yorkshire and one in North Yorkshire.

In all three cases the slopes between the houses and the river/dyke were failing, with rotational movement of the slopes being evident. Moreover, the presence of the water courses, all of which are prone to flooding, the topography of the river banks and the strata conditions were strikingly similar. Therefore, at first sight, it would seem likely that there would be a common link for the observed slope instability. However, in the event it was shown that the actual triggers for the three failures were quite different.

Case 1: The trigger for failure was the presence of the levees on the opposite side of the river as this increased the level of water during flood episodes. As the underlying soils are permeable in nature, water was able to enter the slope. When the flood level subsequently reduced, water flow through the very silty fine sand resulted in a phenomenon known as running sand, thus toe support to the slope was gradually removed such that slumping and progressive failure of the slope occurred, which regressed up the slope.

The recommended remediation included the construction of a sheet piled retaining wall along the river bank and to protect the toe of the slope to reduce the risk of erosion.

Case 2: At this site, the more sensitive fine granular soils were present beneath a capping of less permeable soil, comprising very silty clay. Therefore, the groundwater regime would not be adversely affected by short term flood episodes. However, at this site it was known that a water main had burst and the water was entering the underlying silts via a gully, which resulted in an imbalance in the groundwater profile and failure of the otherwise marginally stable bank ensued.

At the onset of movement, tension cracks developed through the more cohesive soils, thus during future periods of high water the underlying more sensitive silts could be adversely affected by inflowing water. In this case the remediation included the removal of the source of groundwater by properly constructing the outfall from the gully.

Case 3: Similar soils were present at this site and it was known that a surface water outfall pipe between two of the properties had failed. This would suggest a similar mechanism for failure as Case 2. However, at this site there was a timber king post wall supporting the bank of the dyke.
